SR 108 MP 8.89 McDonald Creek: Preliminary Hydraulic Design Report

The proposed project will replace the existing sheet pile and concrete fishway and 63 feet long 4'H x 6'W concrete box culvert with a minimum 18 foot span structure to improve fish passage while providing a safe roadway for the traveling public. This proposed structure is designed to meet the requirements of the federal injunction utilizing the bridge design criteria outlined in the 2013 WDFW Water Crossing Design Guidelines (WCDG).

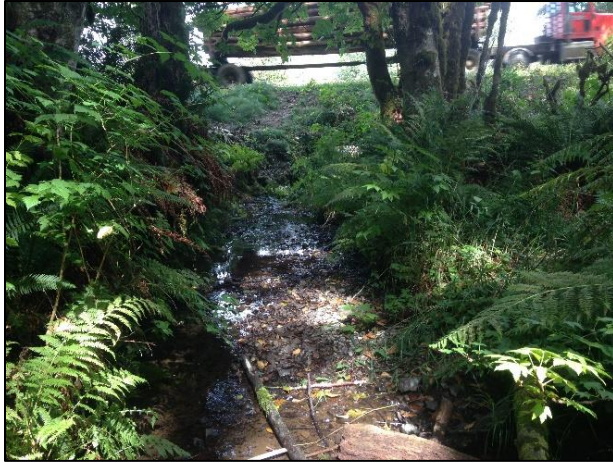
Figure 2 Typical upstream channel

Beginning upstream of the culvert crossing the stream flows through a reach densely vegetated with large trees and shrubs. The upstream reach is composed of pool and riffle sections throughout the channel (shown in Figure 2). Upstream bank heights ranged between 1 to 3 feet with stream benches present throughout the reach. The stream bed sediment was observed to be poorly-sorted and composed of small gravels and cobbles. Significant wood accumulations were observed throughout the upstream reach, and strong potential was noted for further wood recruitment. The stream banks immediately upstream of the culvert inlet are armored with riprap (shown in Figure 3). Two bankfull widths were measured within the upstream reach; the measurements were taken approximately 150 feet and 300 feet upstream of the existing culvert inlet, at 13.5 feet and 11.6 feet respectively. Two

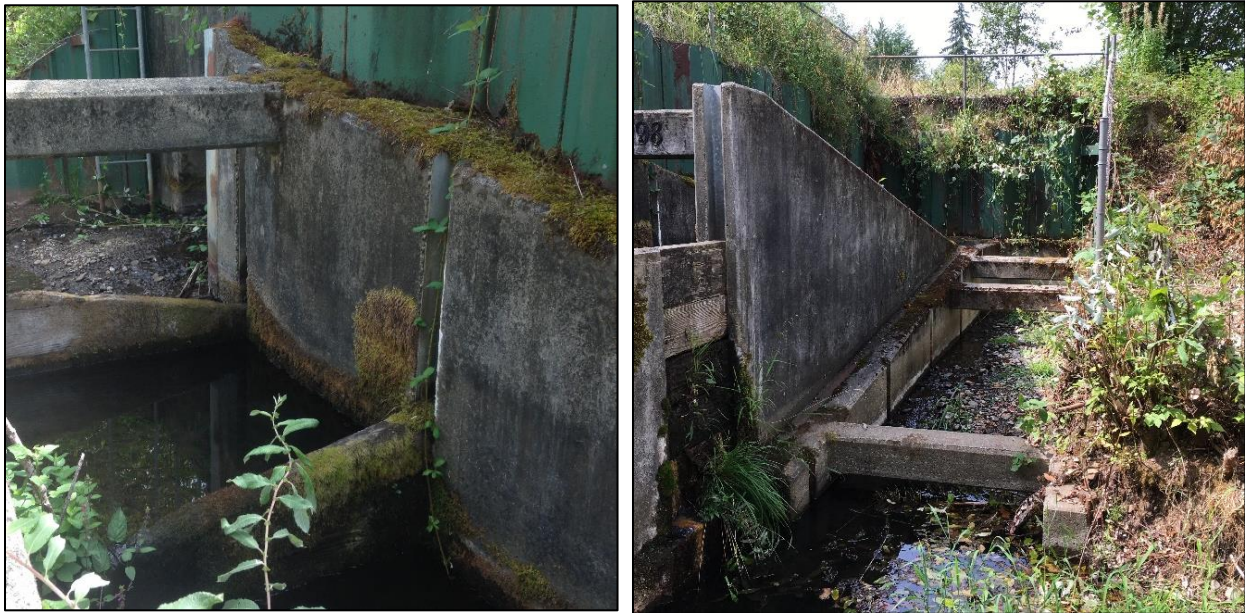
Figure 4 View of concrete fish ladder at downstream end of culvert

At the downstream end of the culvert is an existing 9-pool concrete fish ladder with concrete baffles and an overflow weir controlled with wooden flashboards. According to WDFW, the fish ladder (shown in Figure 4) has failed and become a chronic maintenance problem due to aggradation both within the fish ladder, and in the downstream reach. Significant streambed material was observed within both the existing culvert and fish ladder. The reach downstream of the culvert are densely vegetated with reed

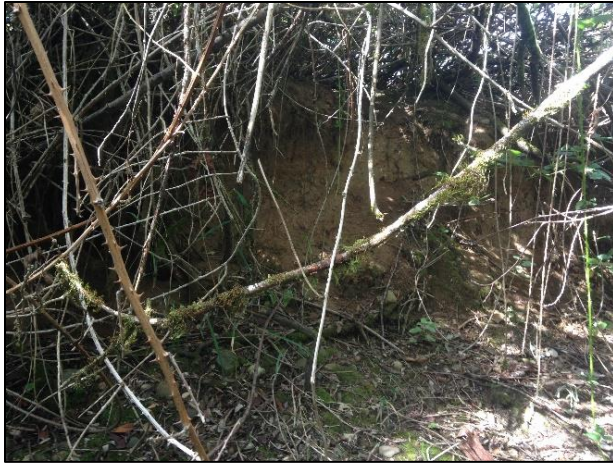
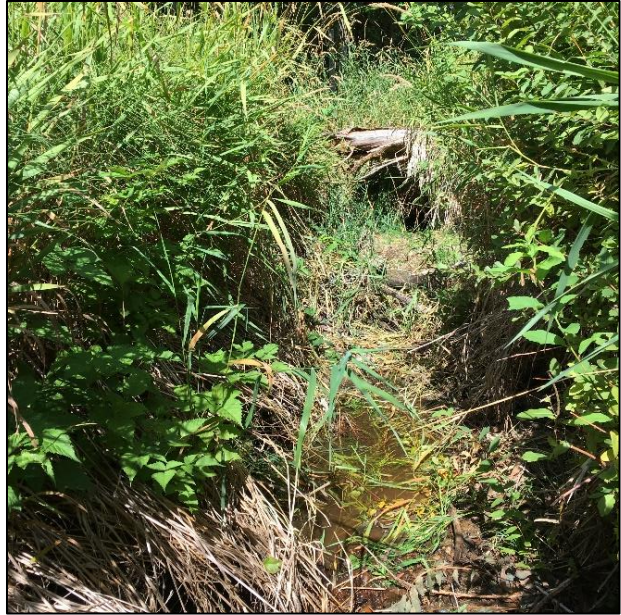
Figure 5 Typical downstream channel, eroded left banks shown at left

canarygrass, blackberry, and small trees (shown in Figure 5). Downstream of the fishway, a pool has formed at the base of the overflow weir. It is suspected that the pool was formed as a result of overtopping of the overflow weir. The channel narrows and becomes incised downstream of the pool, and forms a reach densely vegetated with reed canarygrass. Significant evidence of bank erosion was noted, especially on the left bank throughout the channel downstream of the culvert crossing. Downstream bank heights are taller than upstream, ranging between 3 and 6 feet throughout the reach. The downstream channel is narrower than the upstream channel. The downstream bankfull width was measured approximately 200 feet downstream of the existing culvert at 7.5 feet wide. This downstream measurement was not used for design, but for reach descriptive purposes.

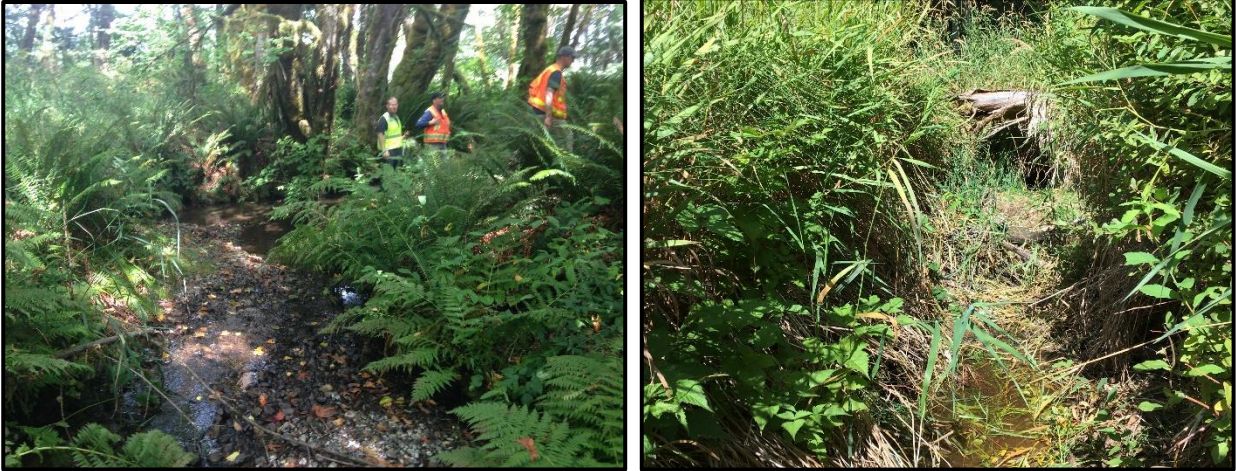
Figure 11 Channel upstream of existing crossing (left) and channel downstream of existing crossing (right)

Channel bed features include pool and riffle sections throughout the observed stream length upstream of the culvert inlet. In the downstream reach, a pool has formed below the fish ladder. The pool is likely caused by higher flows overtopping the weir and scouring the channel area below the weir. Beyond the pool, the channel was observed to be narrow and deeply incised with depth of incision approximately 6 feet (Figure 11).

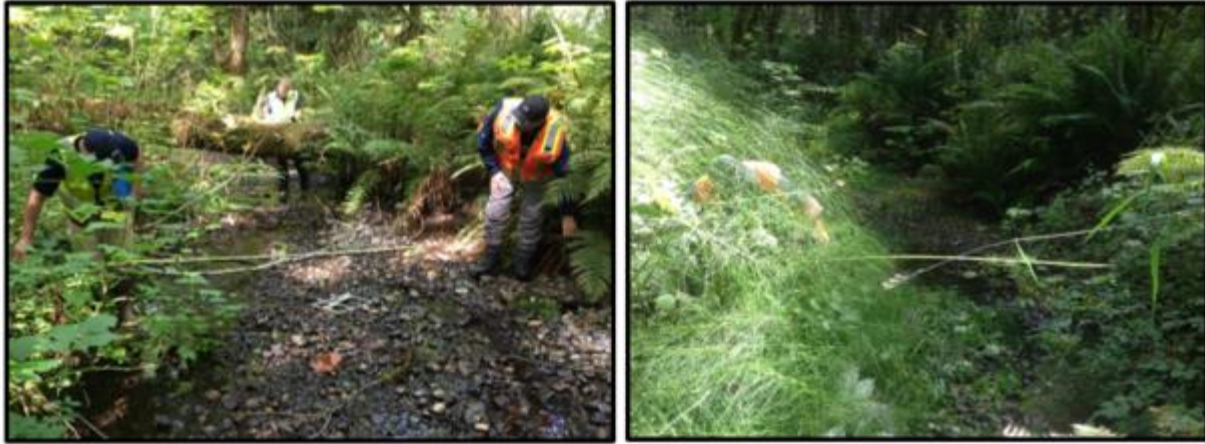
Figure 17 Bankfull width measurements within the reference reach locations

Two bankfull widths were collected during the August 23, 2019 site visit (Figure 17). The first, BFW 1, was measured as 11.6 feet, the second, BFW 2, was measured as 13.5 feet. During the stakeholder site visit WDFW agreed to use three upstream bankfull width measurements, 13.5 feet, 13.5 feet, and 11.8 feet. The first 13.5 feet was from the previously measured BFW 2, and the two new measurements were collected upstream of BFW 2. The average of these three measurements was rounded up to an agreed upon design bankfull width of 13 feet. Bank heights in the reference reach section range between 1 to 3 feet high. Generally, the streambed sediment in the reference reach was observed to poorly-sorted and composed of small gravels and cobbles. Pebble counts were conducted in the reference reach section and the results are summarized above in Section 3.4.6. Additionally, the reference reach contained significant wood accumulations and strong potential for further wood recruitment throughout the length of the upstream reach.

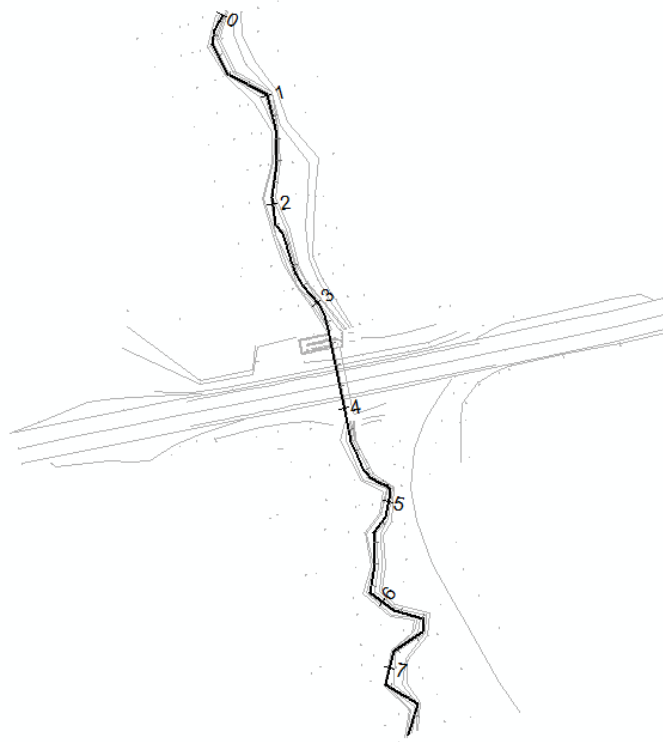
Figure 20 Longitudinal profile stationing for existing and proposed conditions

In addition to cross section results, results were summarized along the longitudinal profile. Both existing and proposed conditions use the same alignment for the purpose of reporting results (Figure 20).

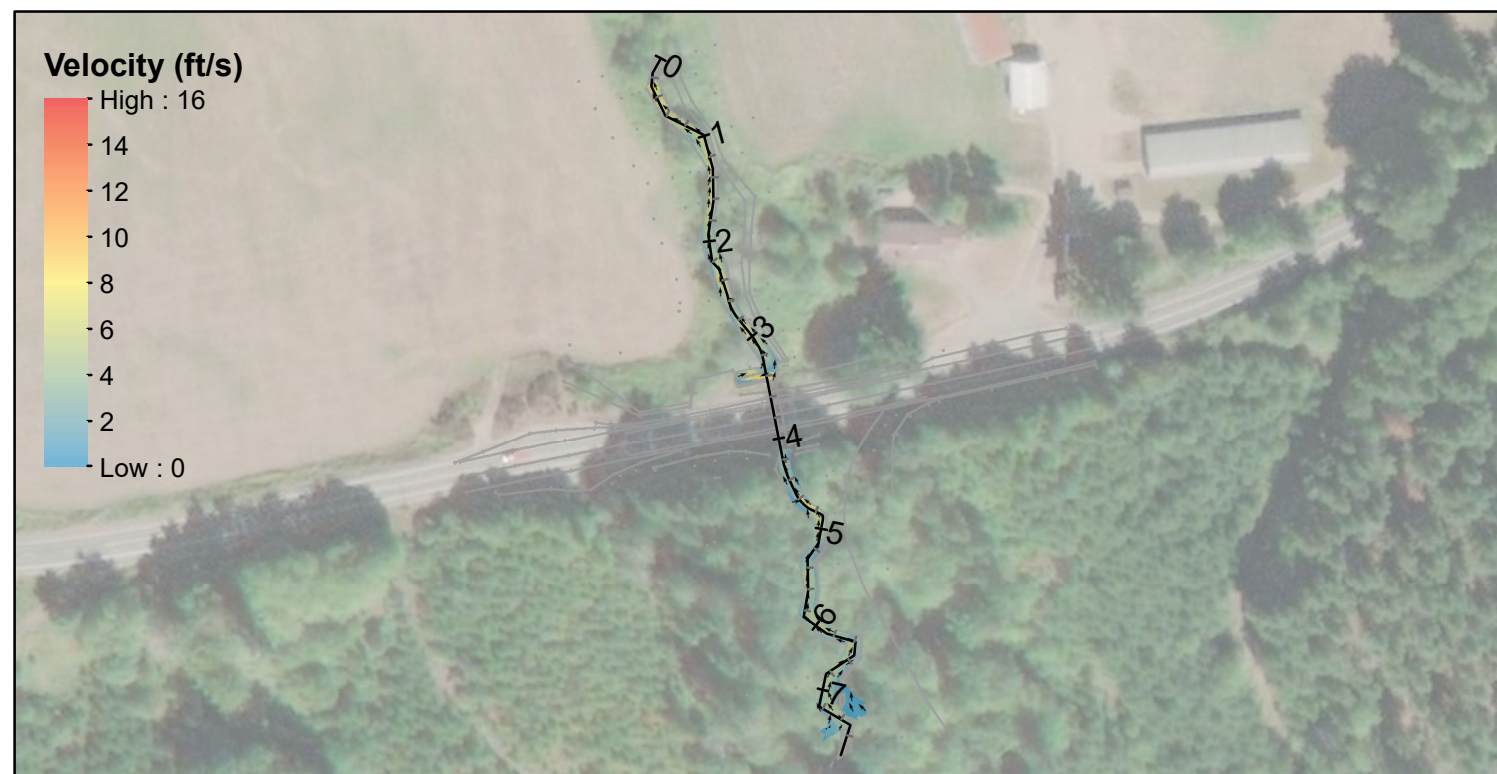
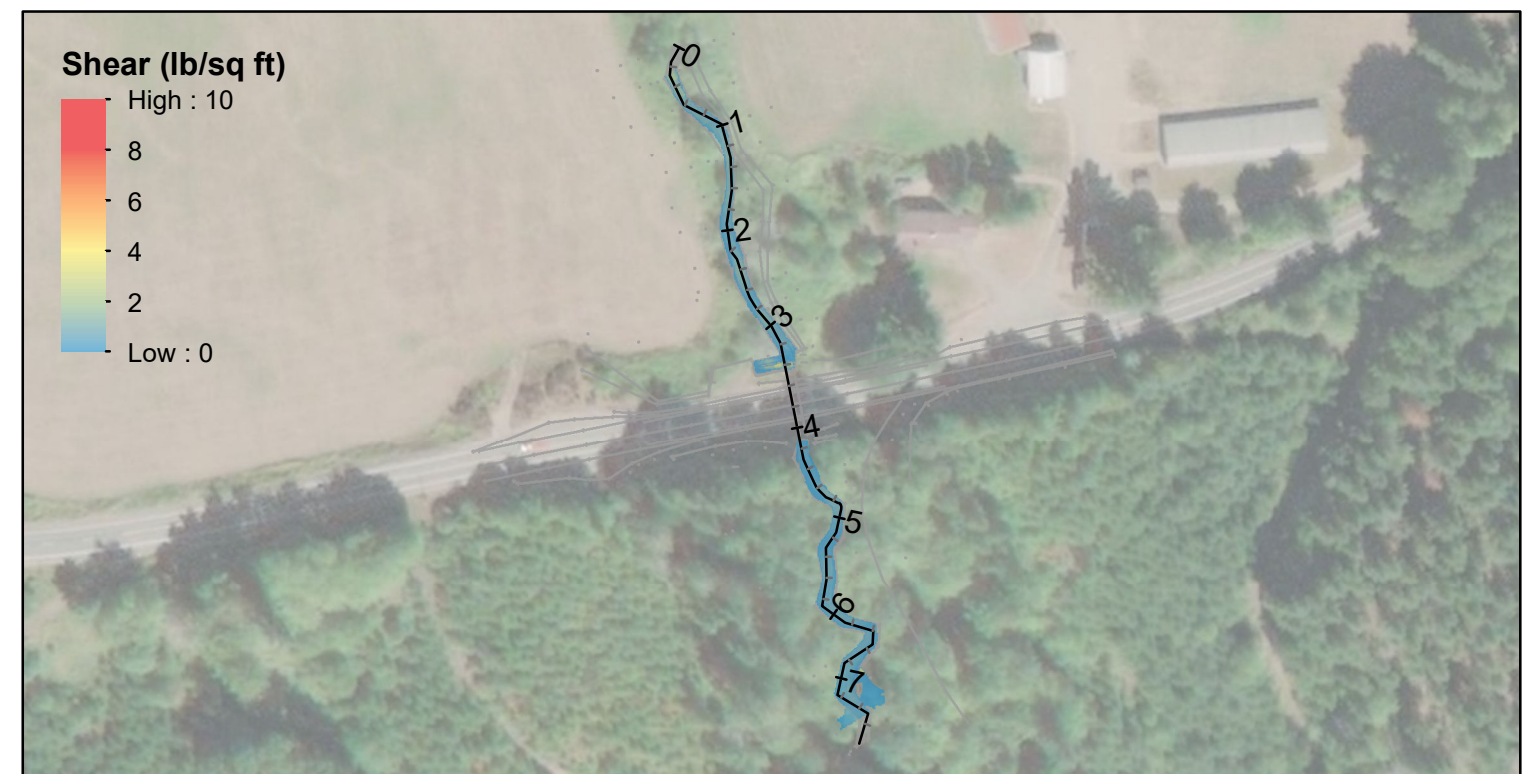
WATER SURFACE ELEVATION

DEPTH

VELOCITY

SHEAR

EXISTING CONDITIONS - 2 YEAR EVENT

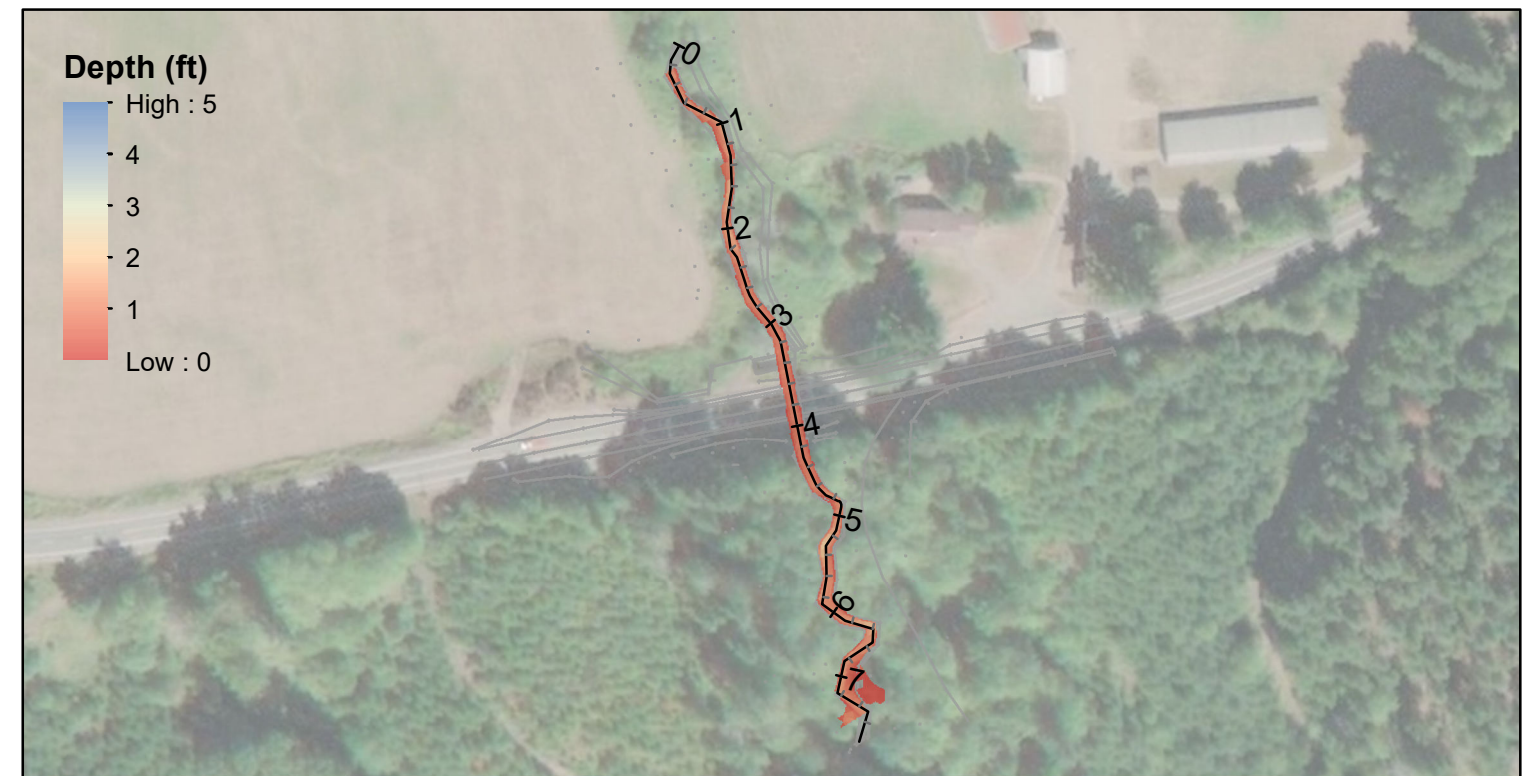
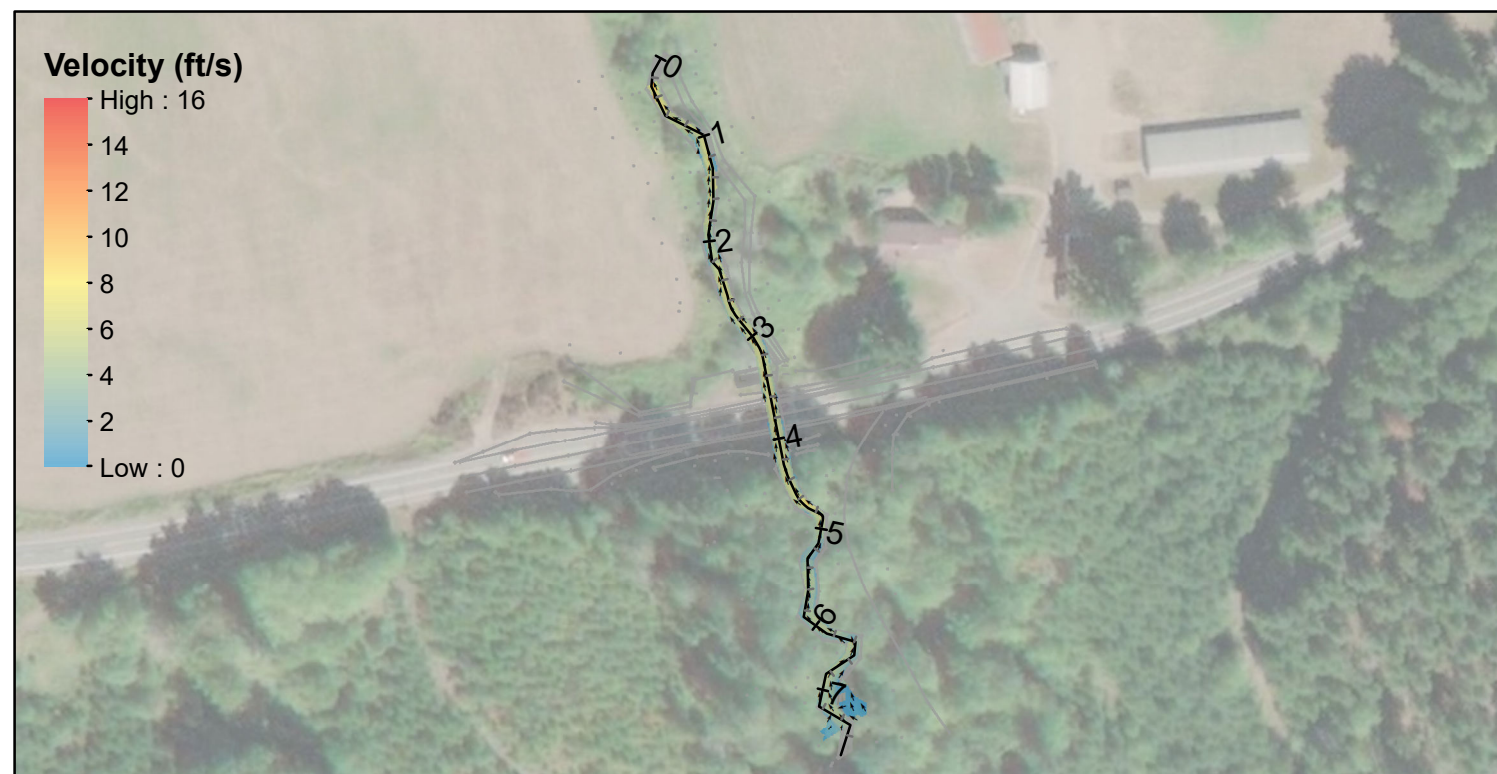
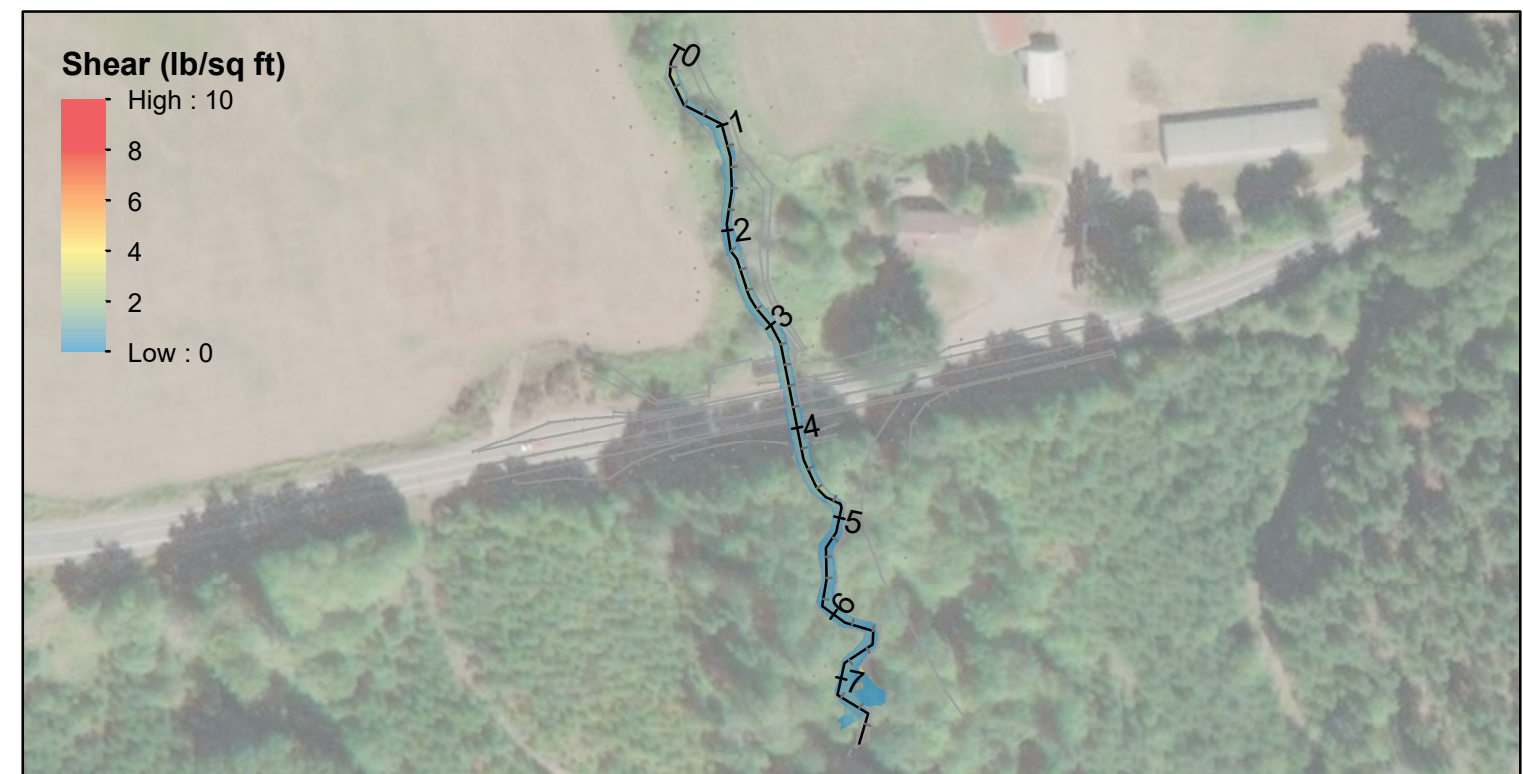
WATER SURFACE ELEVATION

DEPTH

VELOCITY

SHEAR

PROPOSED CONDITIONS - 2 YEAR EVENT

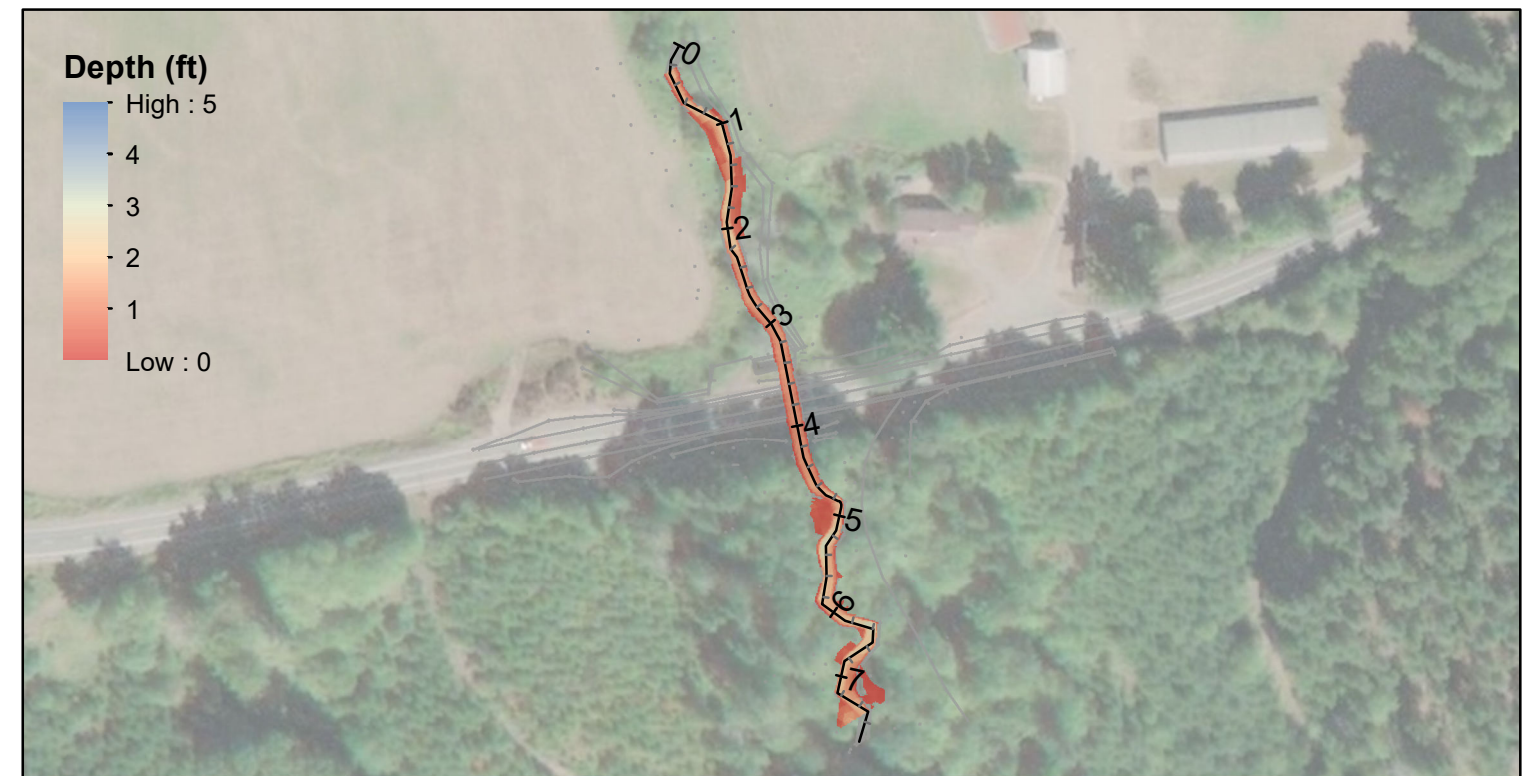
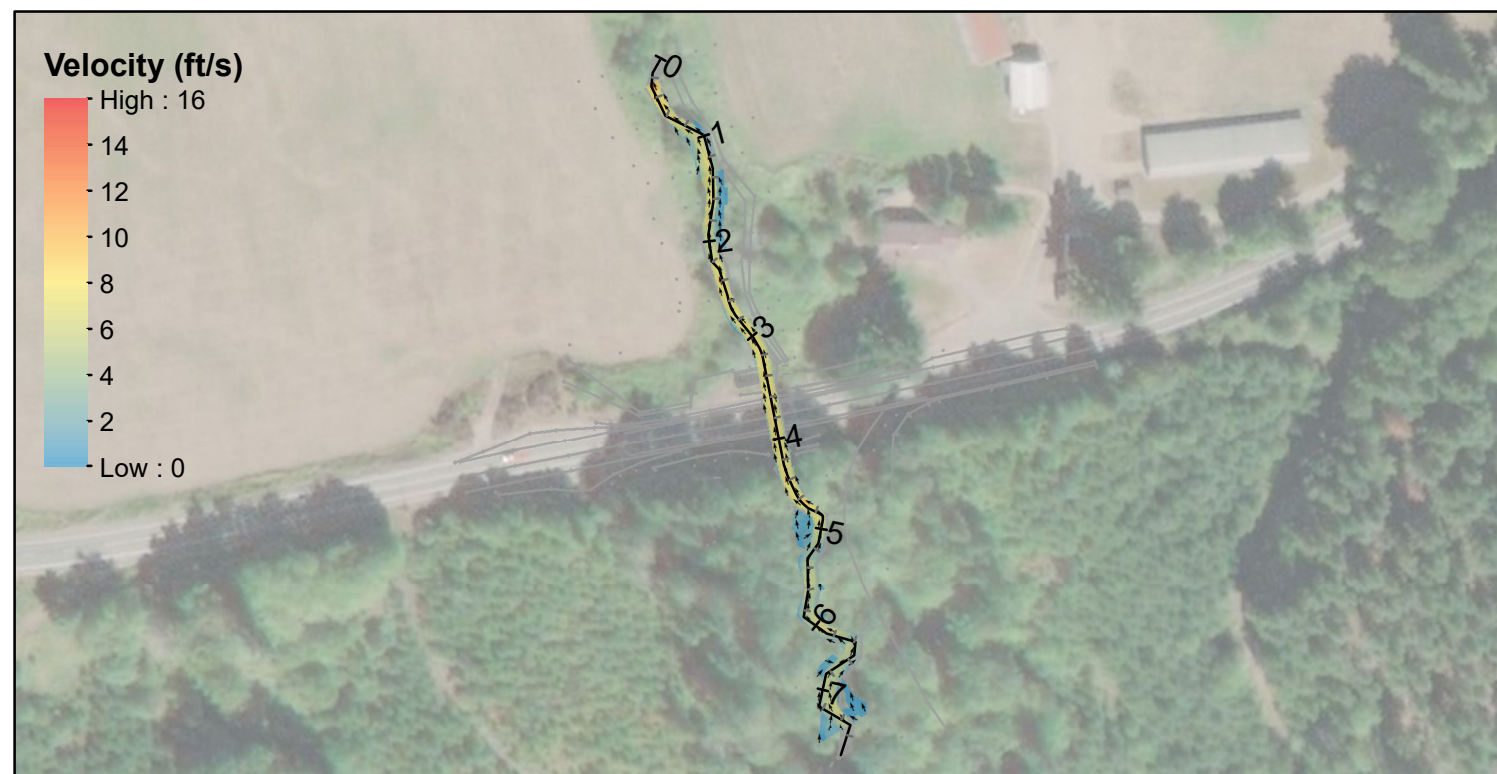
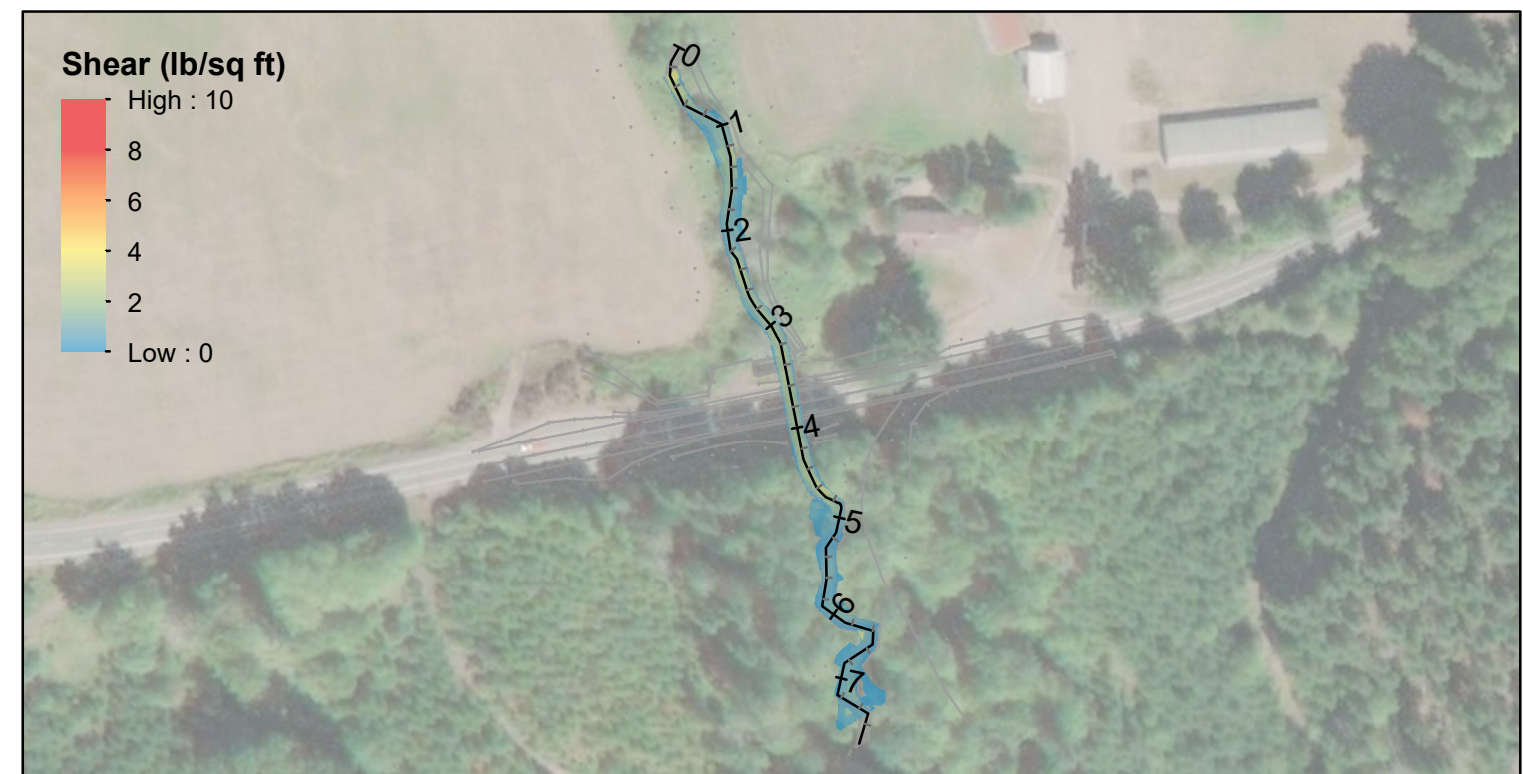
WATER SURFACE ELEVATION

DEPTH

VELOCITY

SHEAR

PROPOSED CONDITIONS - 25 YEAR EVENT

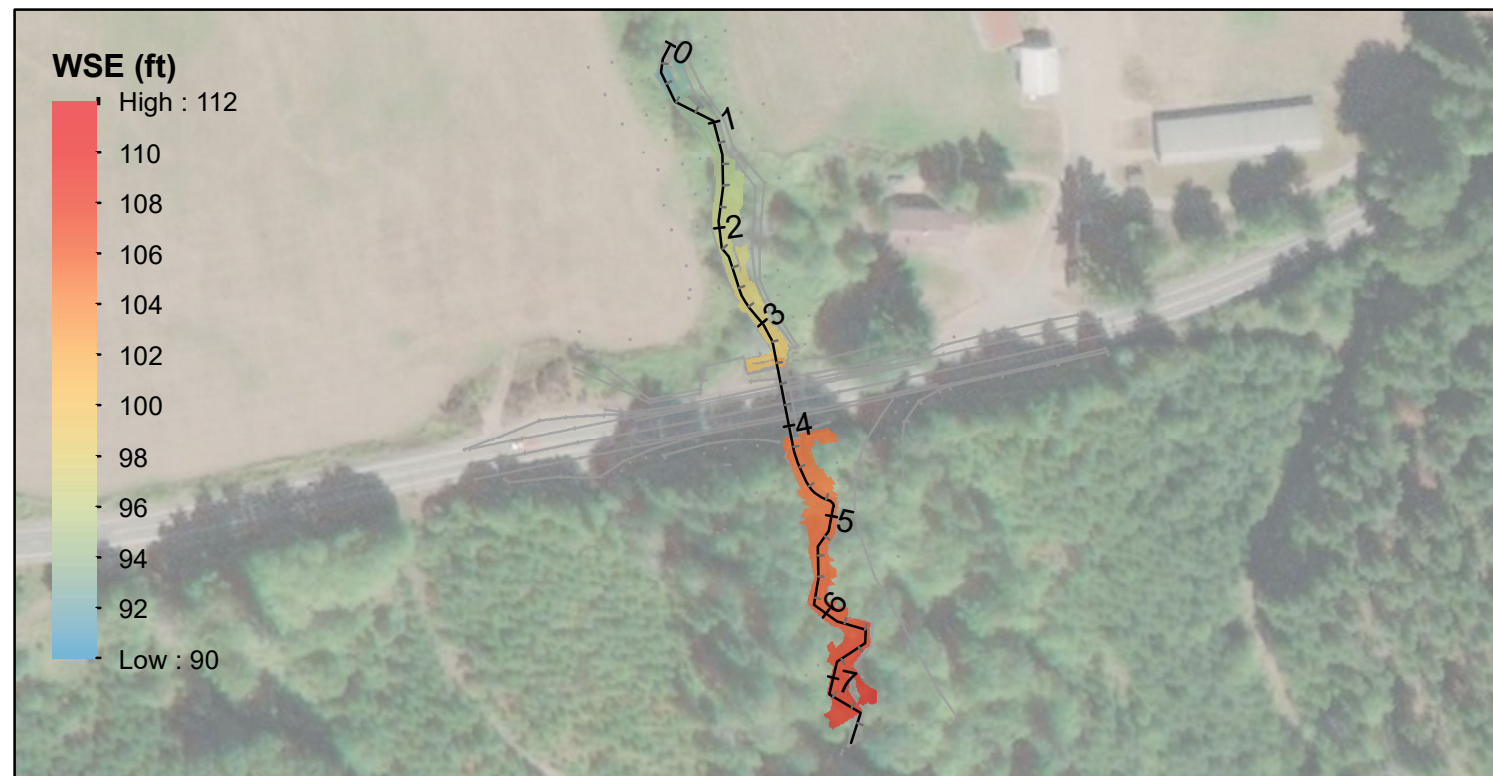
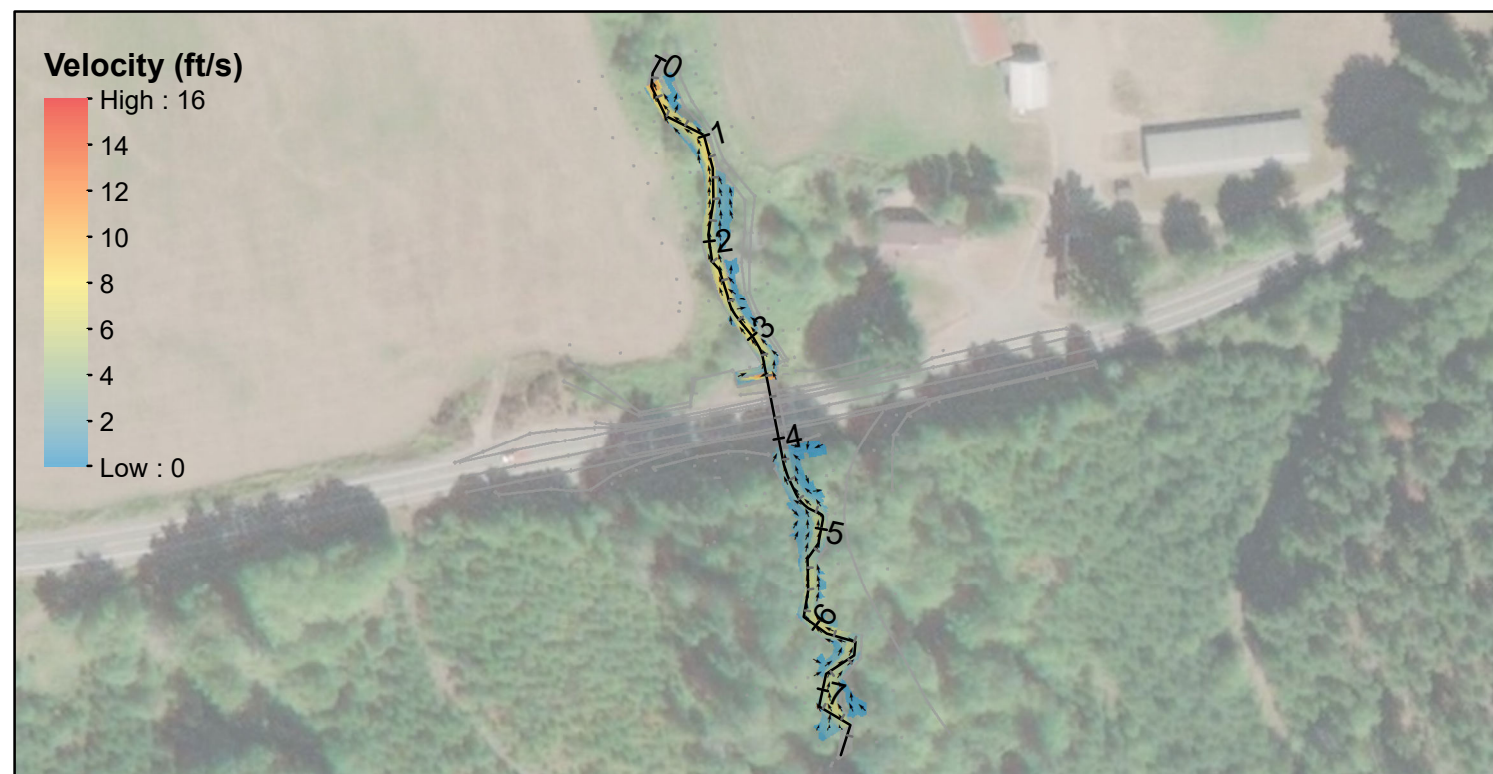
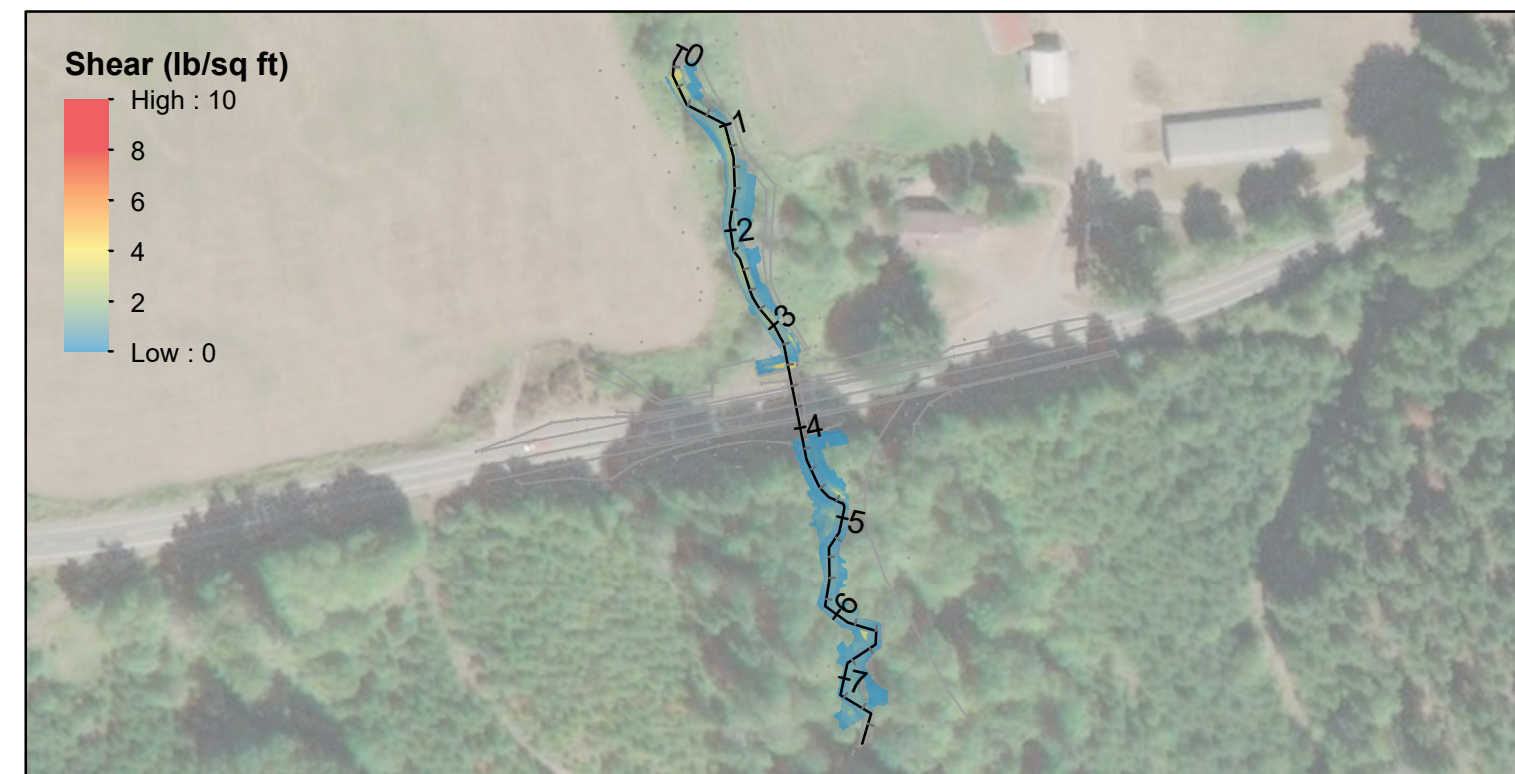
WATER SURFACE ELEVATION

DEPTH

VELOCITY

SHEAR

EXISTING CONDITIONS - 50 YEAR EVENT

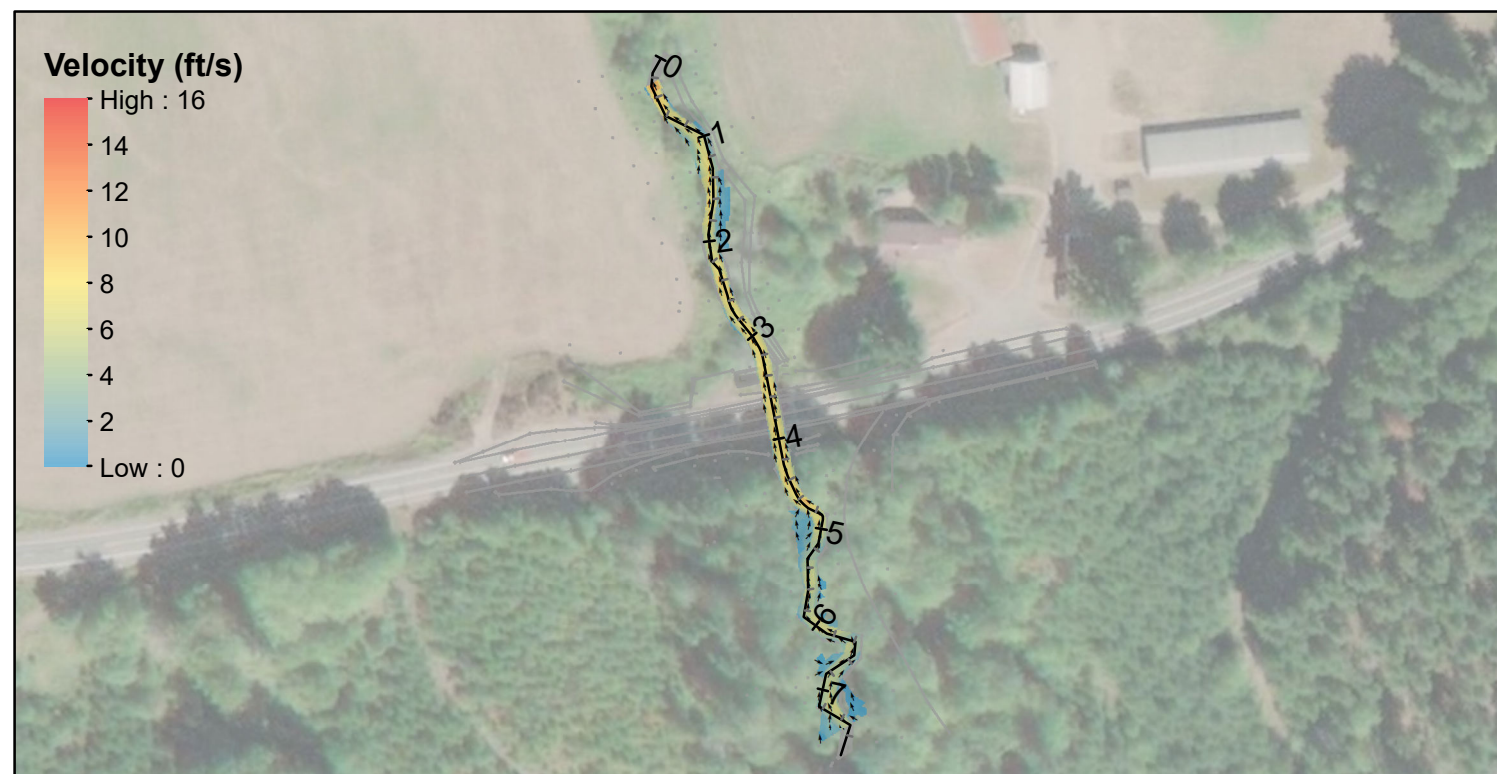
WATER SURFACE ELEVATION

DEPTH

VELOCITY

SHEAR

PROPOSED CONDITIONS - 50 YEAR EVENT

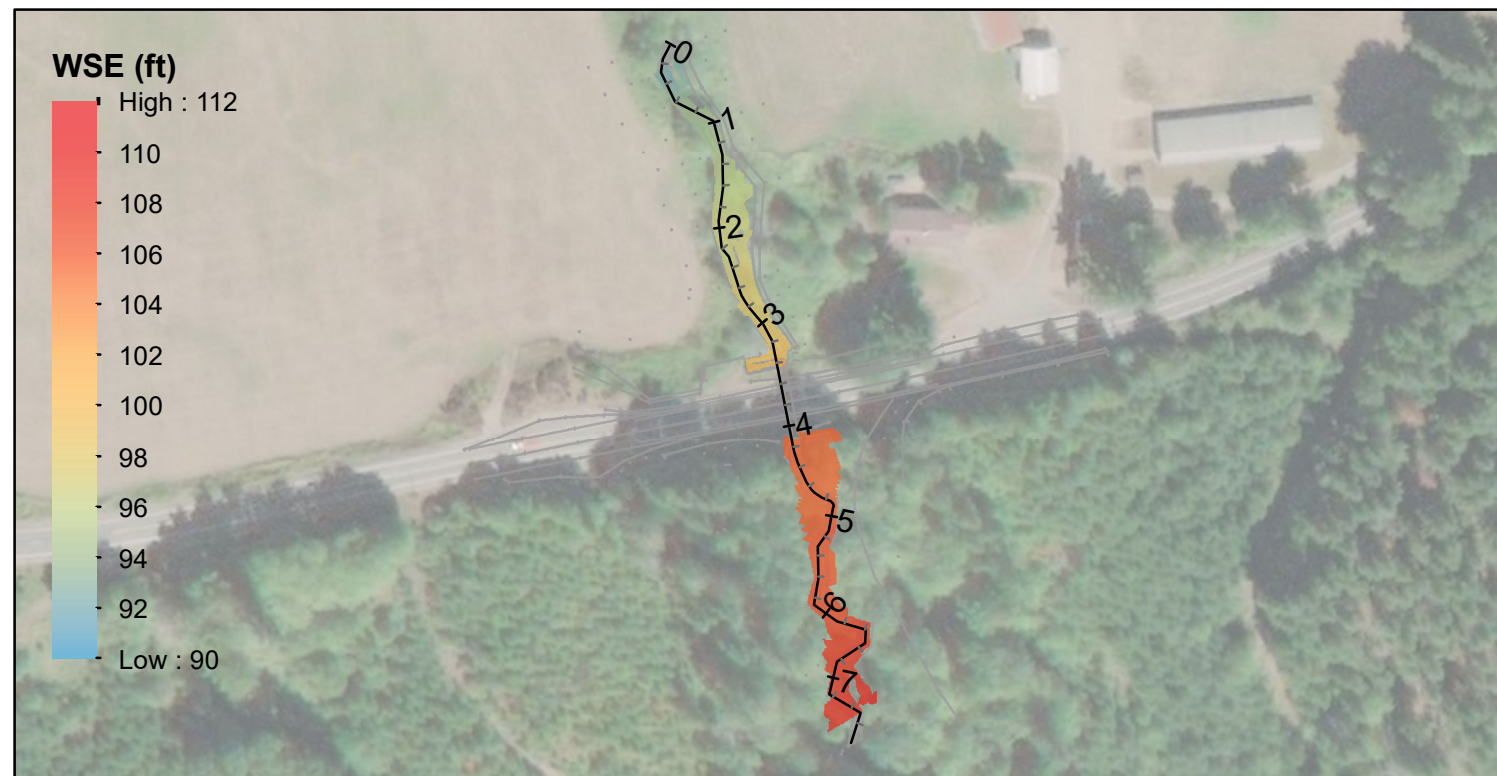
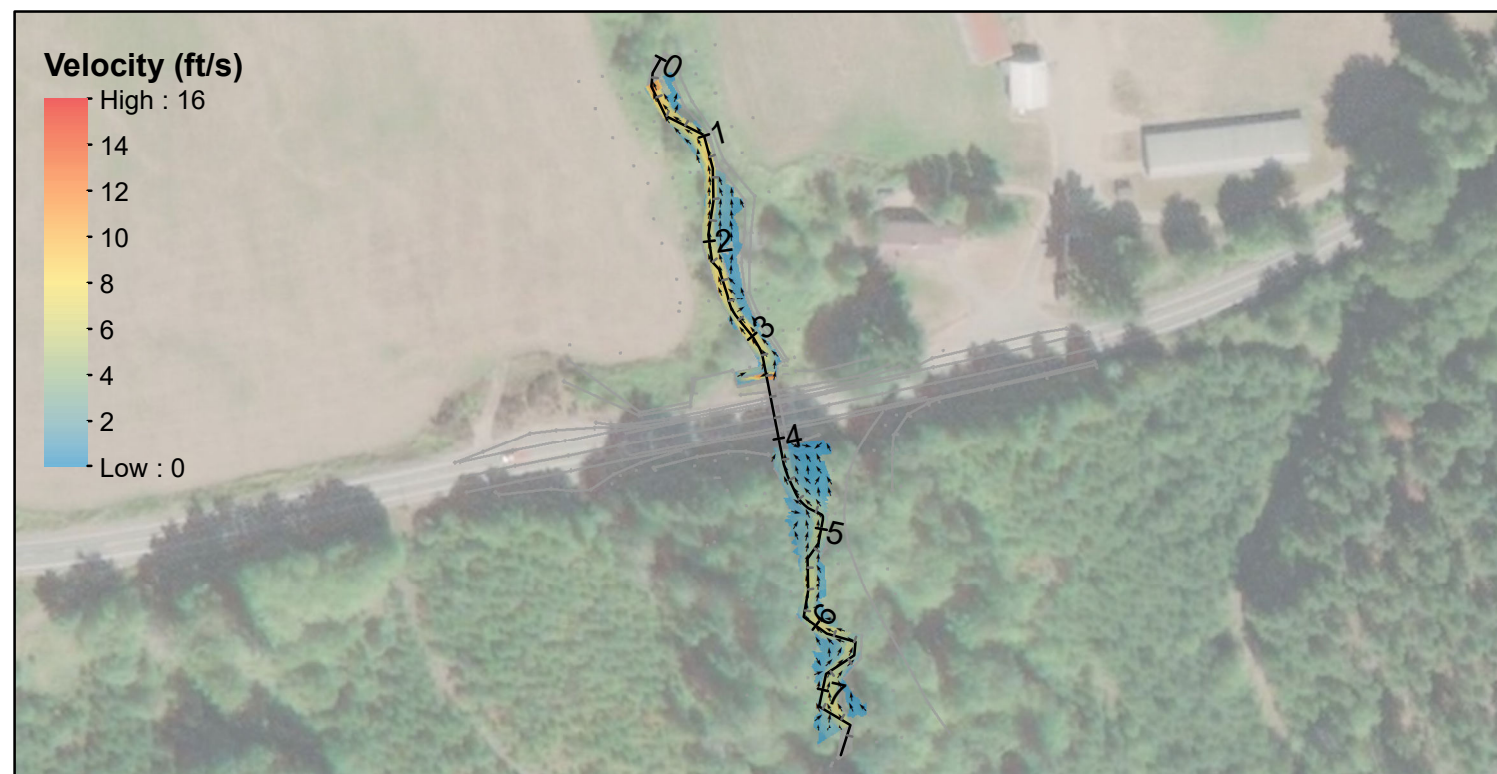
WATER SURFACE ELEVATION

DEPTH

VELOCITY

SHEAR

EXISTING CONDITIONS - 100 YEAR EVENT

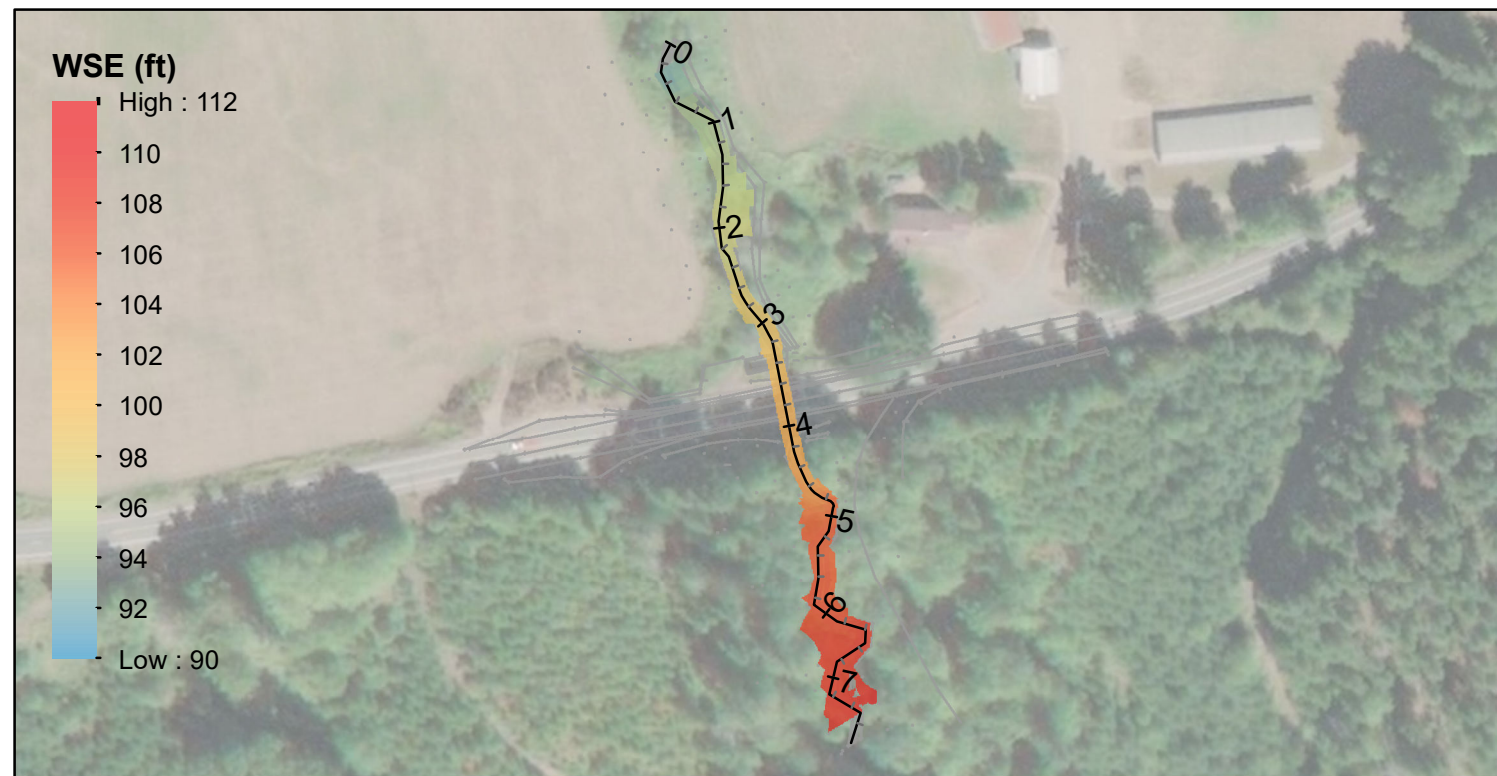
EXISTING CONDITIONS - 500 YEAR EVENT
